Report No. FHWA/RD-80/059

# EVALUATION OF HIGHWAY CULVERT COATING PERFORMANCE

June 1980  
Final Report

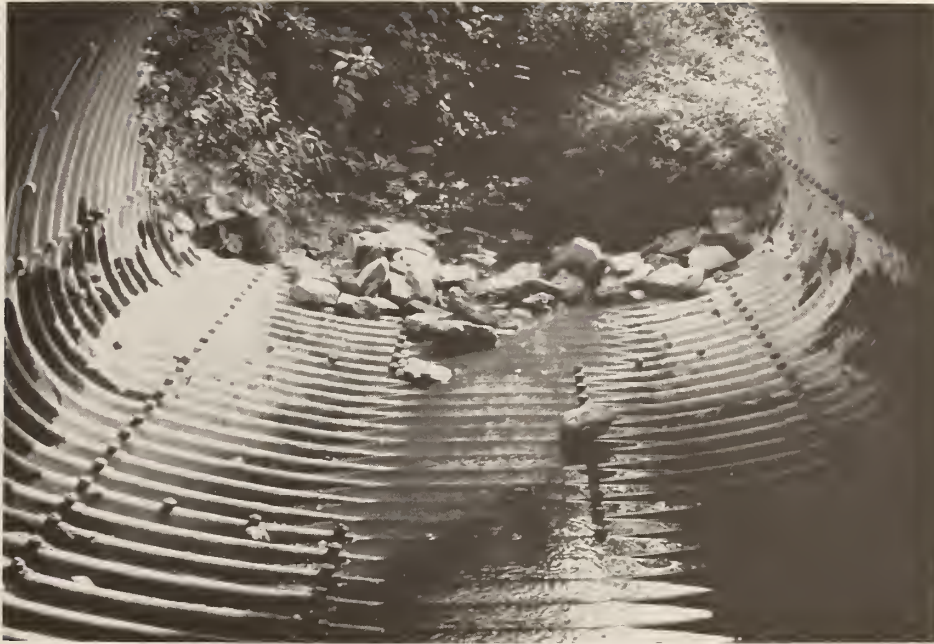
Figures 7 and 8 illustrate two culverts with field applied mastic which were subject to abrasive flow conditions. Figure 9 shows a culvert with field applied mastic exposed to alkali water. Generally speaking, the field applied mastics inspected exhibited poor performance. Coating thickness measurements revealed that coatings were not uniformly applied. The average thickness being below the .127 cm (.050-inch) minimum specified by AASHTO and the states.

FIGURE 7 Field Applied Asphalt Mastic  
Site No. 7

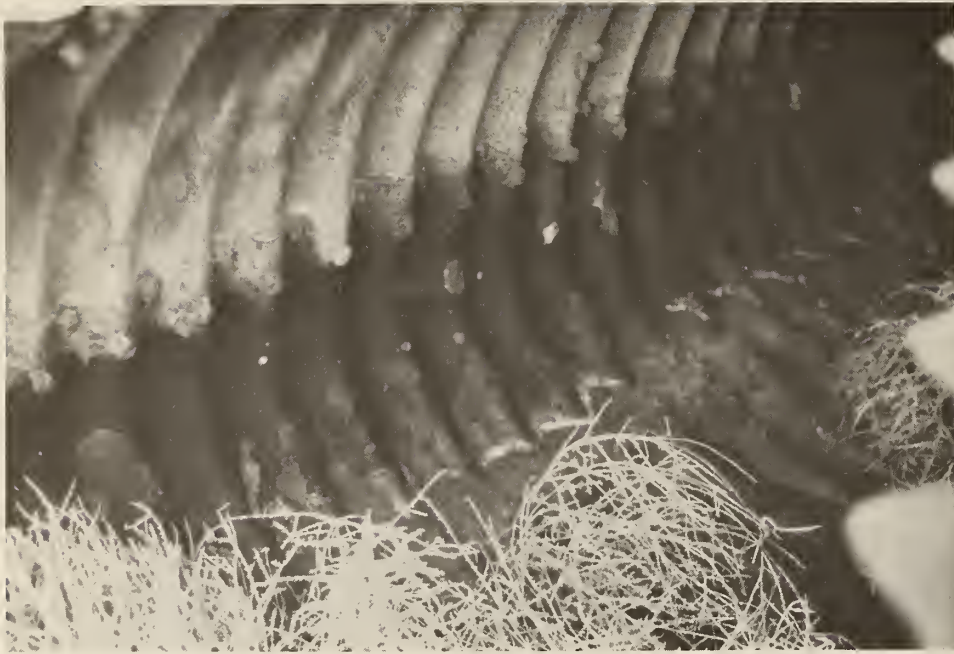
FIGURE 9 - Field Applied Asphalt Mastic  
Site No. 29

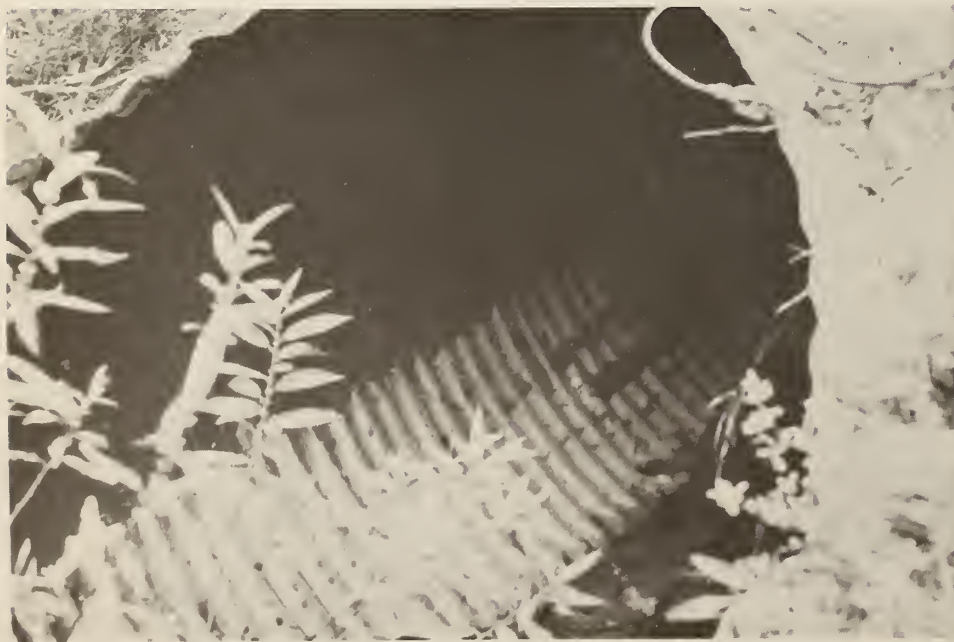
Figures 10 and 11 illustrate damage to asphalt dipped culvert pipe. The damage in Figure 10 was caused by abrasion and impact while that in Figure 11 was

FIGURE 10 - Asphalt. Site No. 16

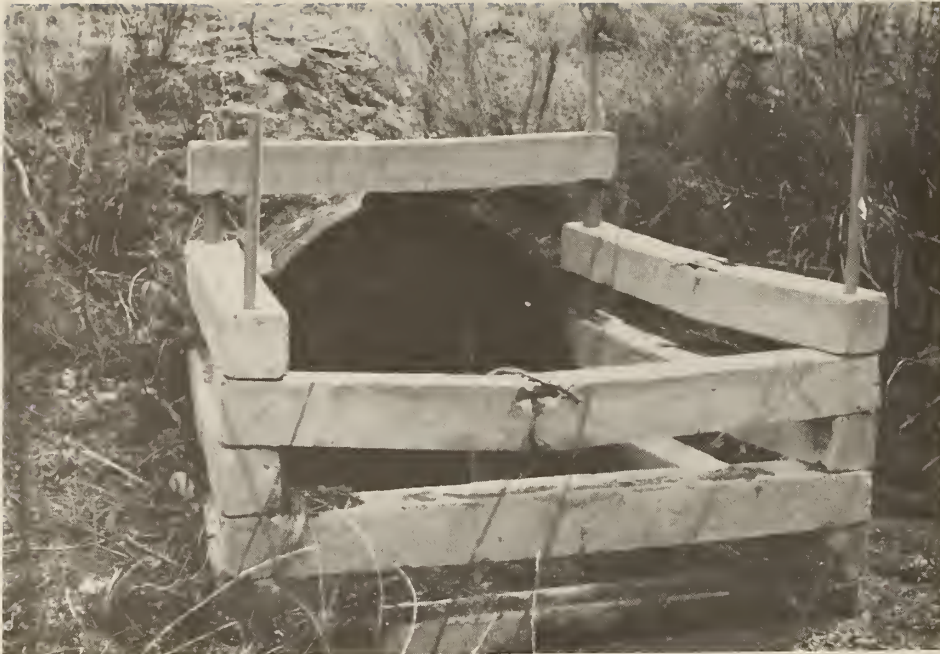
FIGURE 13 - Crib to Control large debris  
that might plug culvert. Site  
No. 63

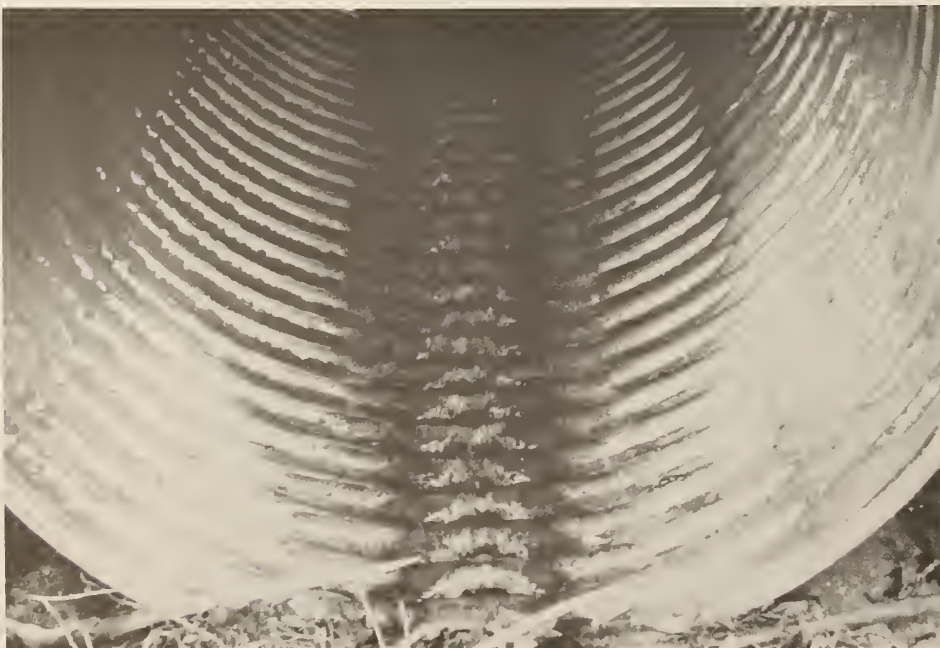
FIGURE 14 - Asphalt Coated Pipe in Figure  
13. Site No. 63

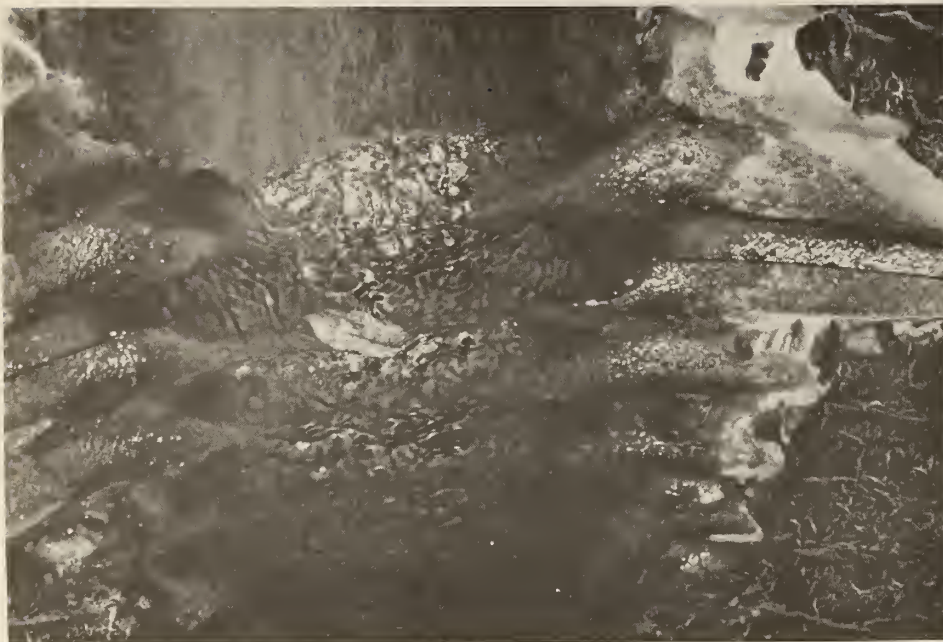
FIGURE 17 - Perforation at Section Joint.  
Site No. 19

6. Seal the space at joints between pipe sections to reduce turbulence and lessen the chance of coating and culvert deterioration at these locations. Only the invert area exposed to normal stream flow conditions need be considered for this treatment. A hot poured asphalt would probably be the most effective sealant.

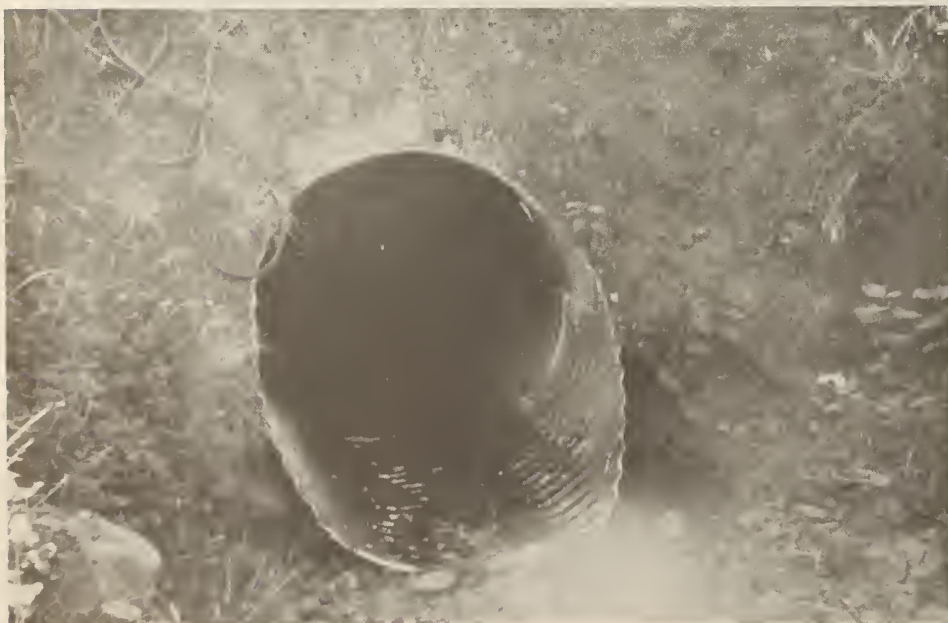
Inspections included only four asphalt coated aluminum culverts (two at test sites). Figure 18 shows a three year old aluminum coated culvert which was installed with a settling basin at the inlet. Some chipping of the coating is seen on the invert. Coatings on both aluminum culverts examined in field use were in good condition with little coating deterioration and no corrosion of the aluminum. Abrasion and rapid stream flows did not appear to be factors in the two culverts examined. Asphalt exhibits a poor bond to aluminum, being easily removed by prying. Figure 19 shows a test culvert from Louisiana exposed to a moderately corrosive environment in which almost no coating remains. While the condition in Figure 19 could be the result of periodic removals during inspections, it does illustrate the poor adhesion between aluminum and asphalt when conventional application techniques are used.

FIGURE 18 - Asphalt Coated Aluminum.  
Site No. 25
